Re: **Mr. Robert Eichenour Private Homeowner Construction Site; Construction Stormwater; SIC 1522; NPDES Compliance Evaluation Inspection; NPDES #NMU001987; February 27, 2019**

## NPDES Compliance Inspection Report

**Inspection Report: Clean Water Act Section 401 & 404**  
**La Canada Del Carro**  
**Surface Water Quality Bureau (SWQB)**  
**Watershed Protection Section**

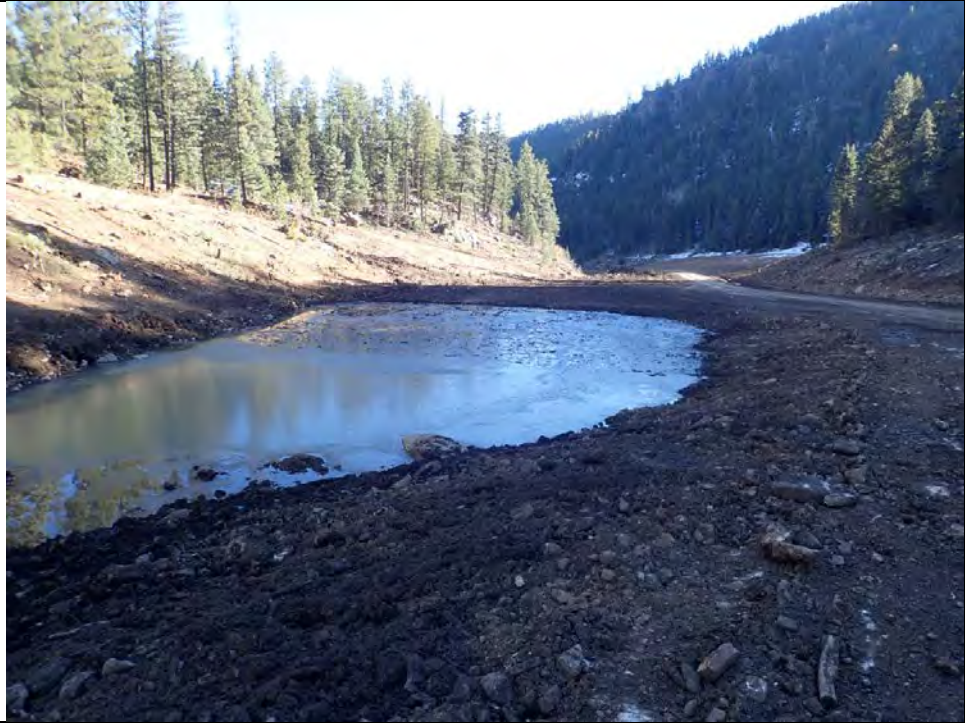
Photo 13

Bottom of the newly  
created pond located  
within La Canada  
del Carro..

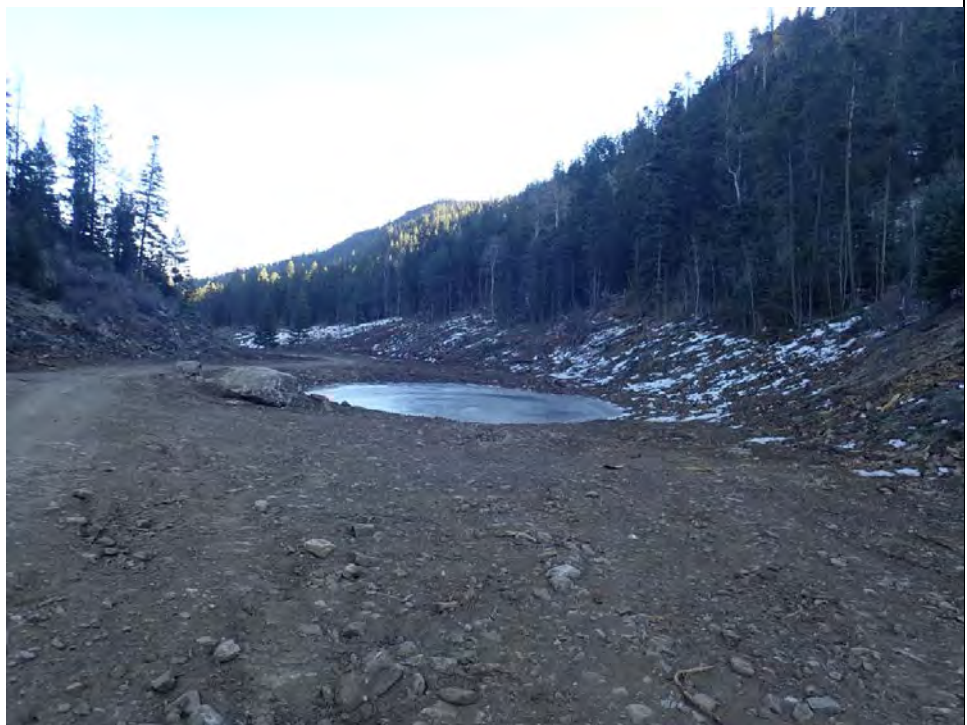
Photo 14

A second newly  
created pond located  
within La Canada  
del Carro..

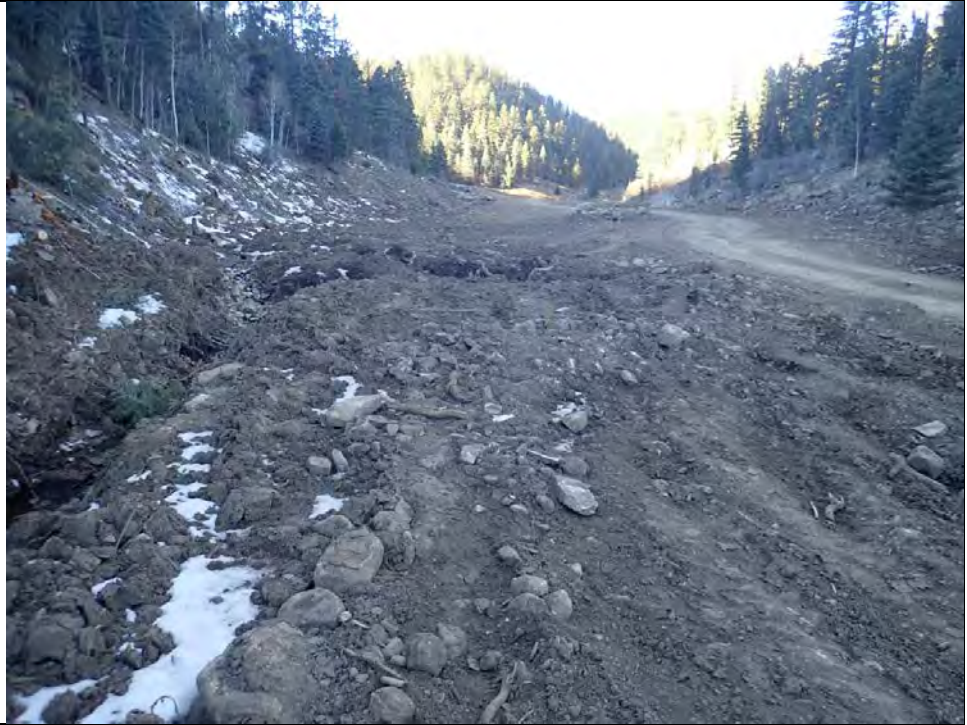
Photo 15

Further downstream, looking up valley at the continued disturbance and relocation of La Canada de Carro.

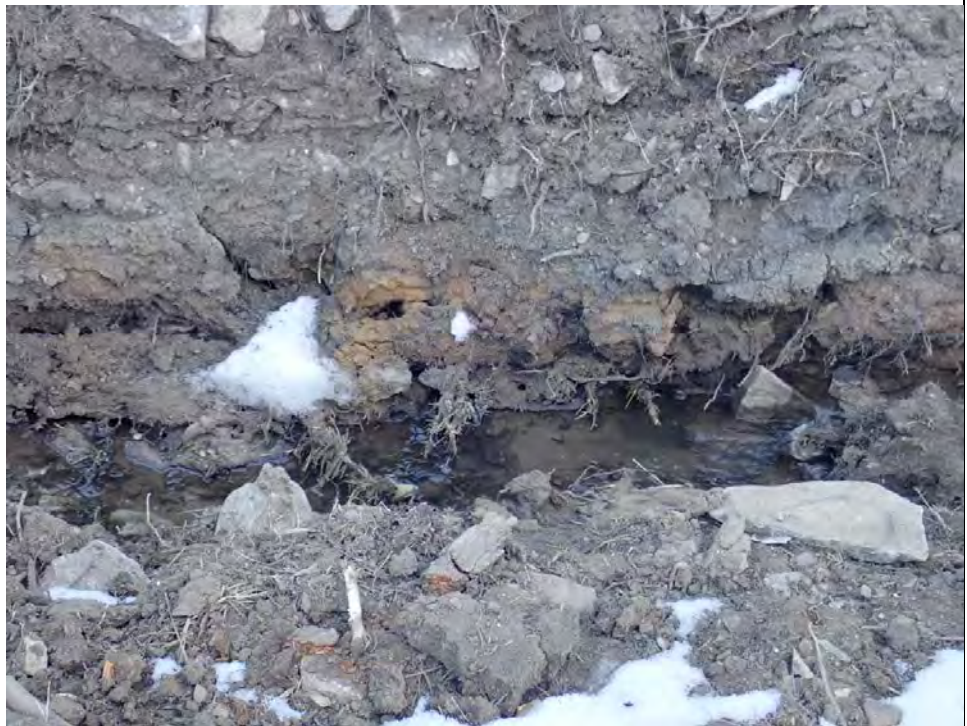
Photo 16

Redoximorphic soil features shown here are indicative of wetland soils. Trenching through a wetland and relocating the channel to this location will likely result with these routinely saturated soils being drained at an increased rate and saturated less frequently.

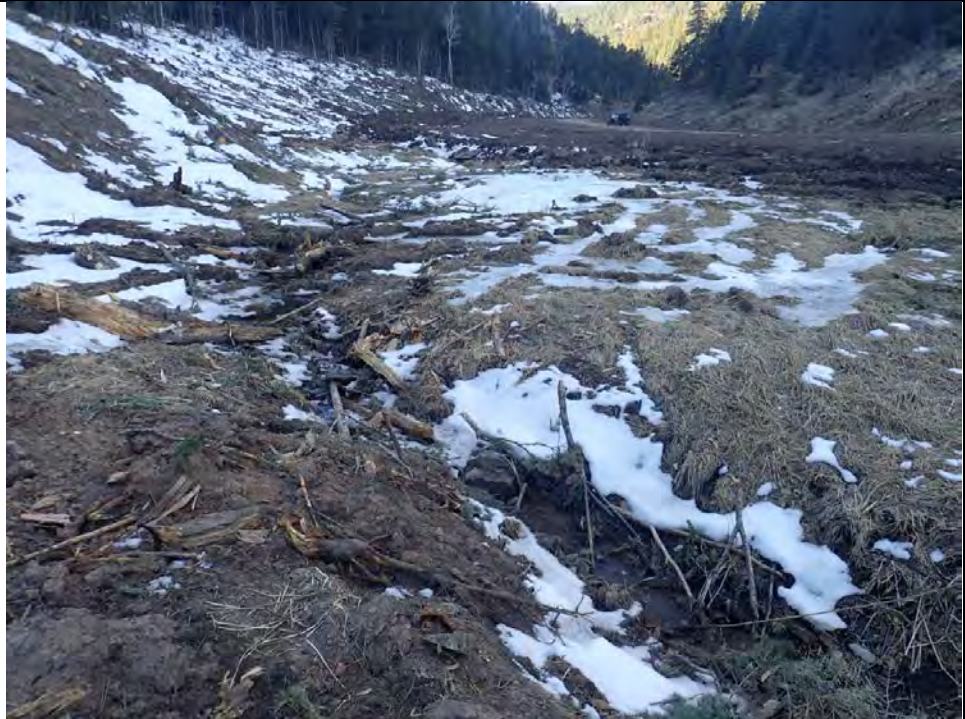
Photo 17

Looking up valley, bare ground and tree debris indicates continued activity along La Canada del Carro. An area of dormant sedges, a wetland indicator species, was left undisturbed and is shown in the right side of this photo.

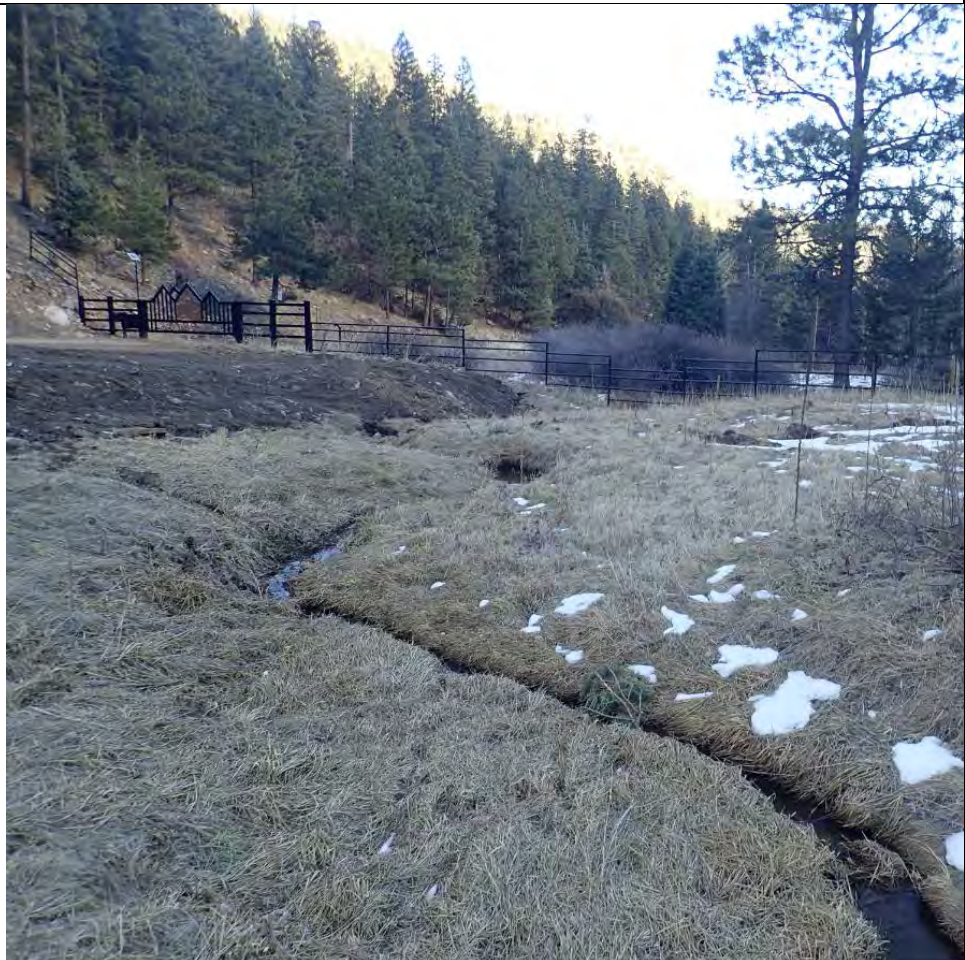
Photo 18

Looking downvalley at the bottom most portion of the site visit. Approximately 150 feet of channel was not disturbed and may potentially be used as a reference reach for restoration efforts upstream.

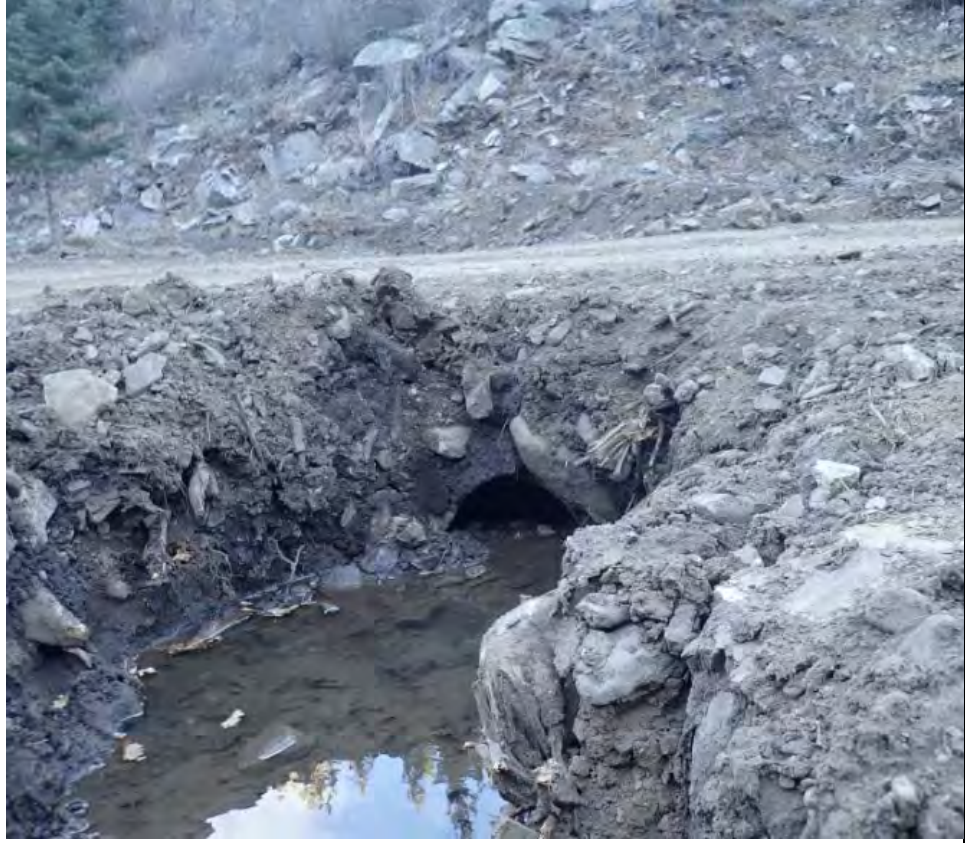
Photo 19

A poorly designed, constructed and/or maintained culvert that is at risk of being blocked and overtopping the road and contributing to increased sediment loading.
